# DIMINISHED VALUE OF OREGON

## Motor Vehicle Loss of Value Report

<b>OWNER</b>		<b>REPAIR FACILITY</b>	
<b>DATE OF LOSS</b>		<b>USED CAR MARKET</b>	Pacific Northwest
<b>VEHICLE</b>	2016 Volvo XC90 T6 - R- Design 4D SUV AWD	<b>VIN</b>	
<b>PRE-LOSS CONDITION</b>	Very Clean	<b>MILEAGE AT LOSS</b>	2,537

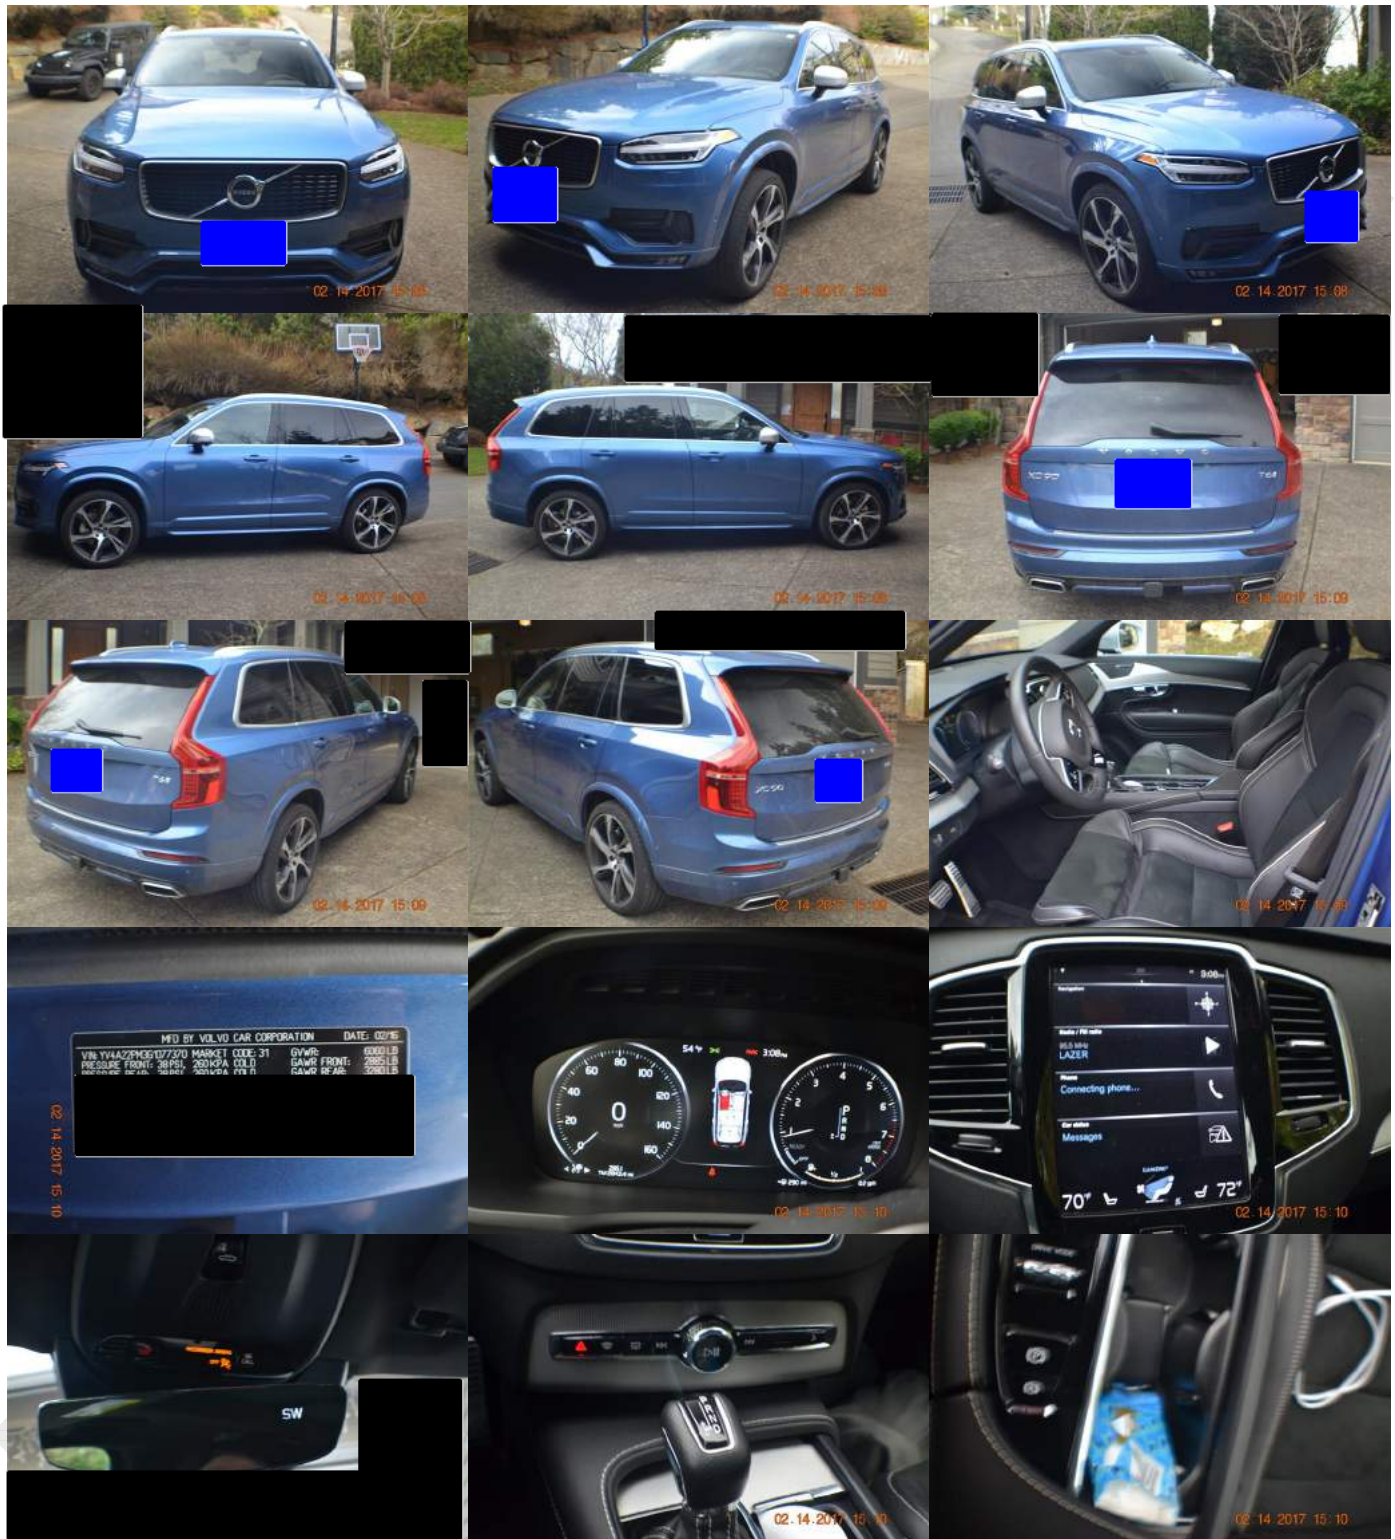
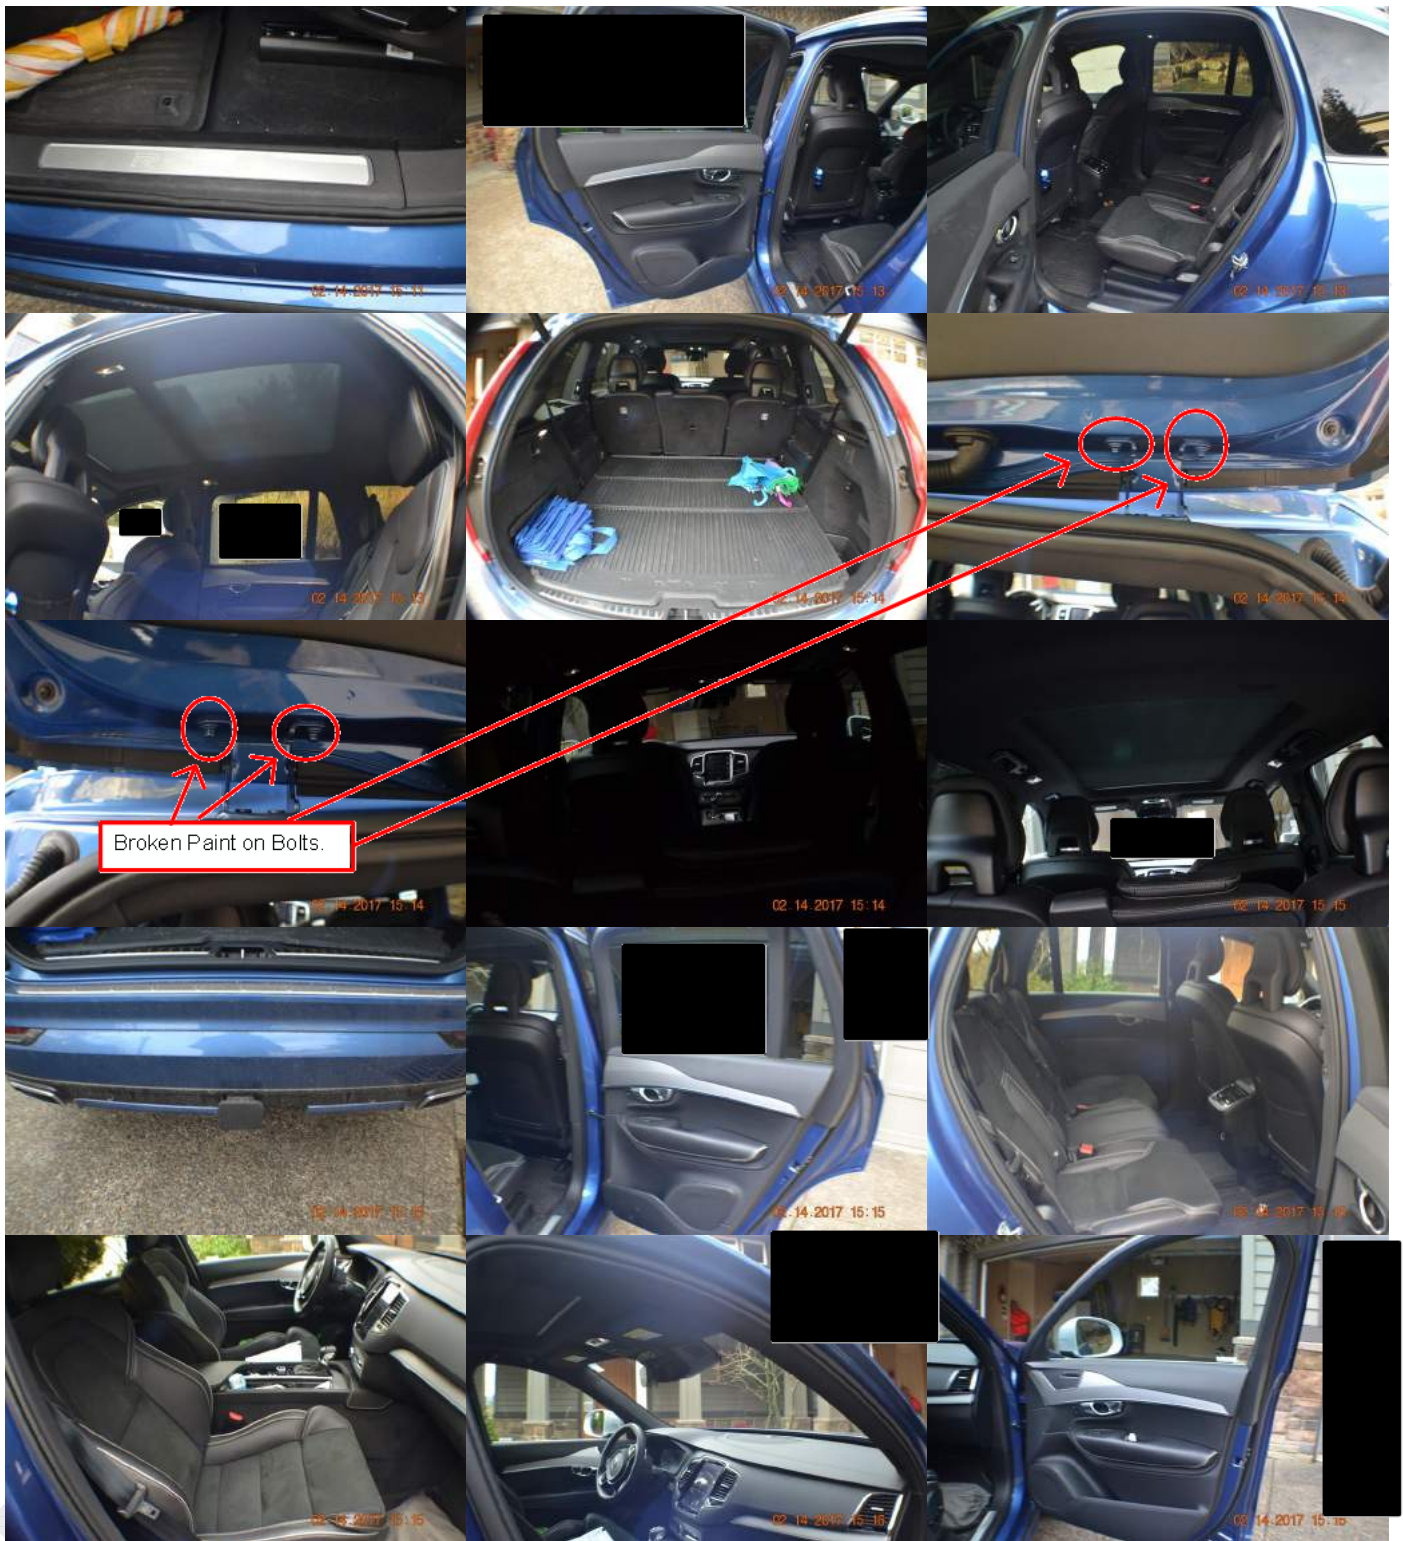
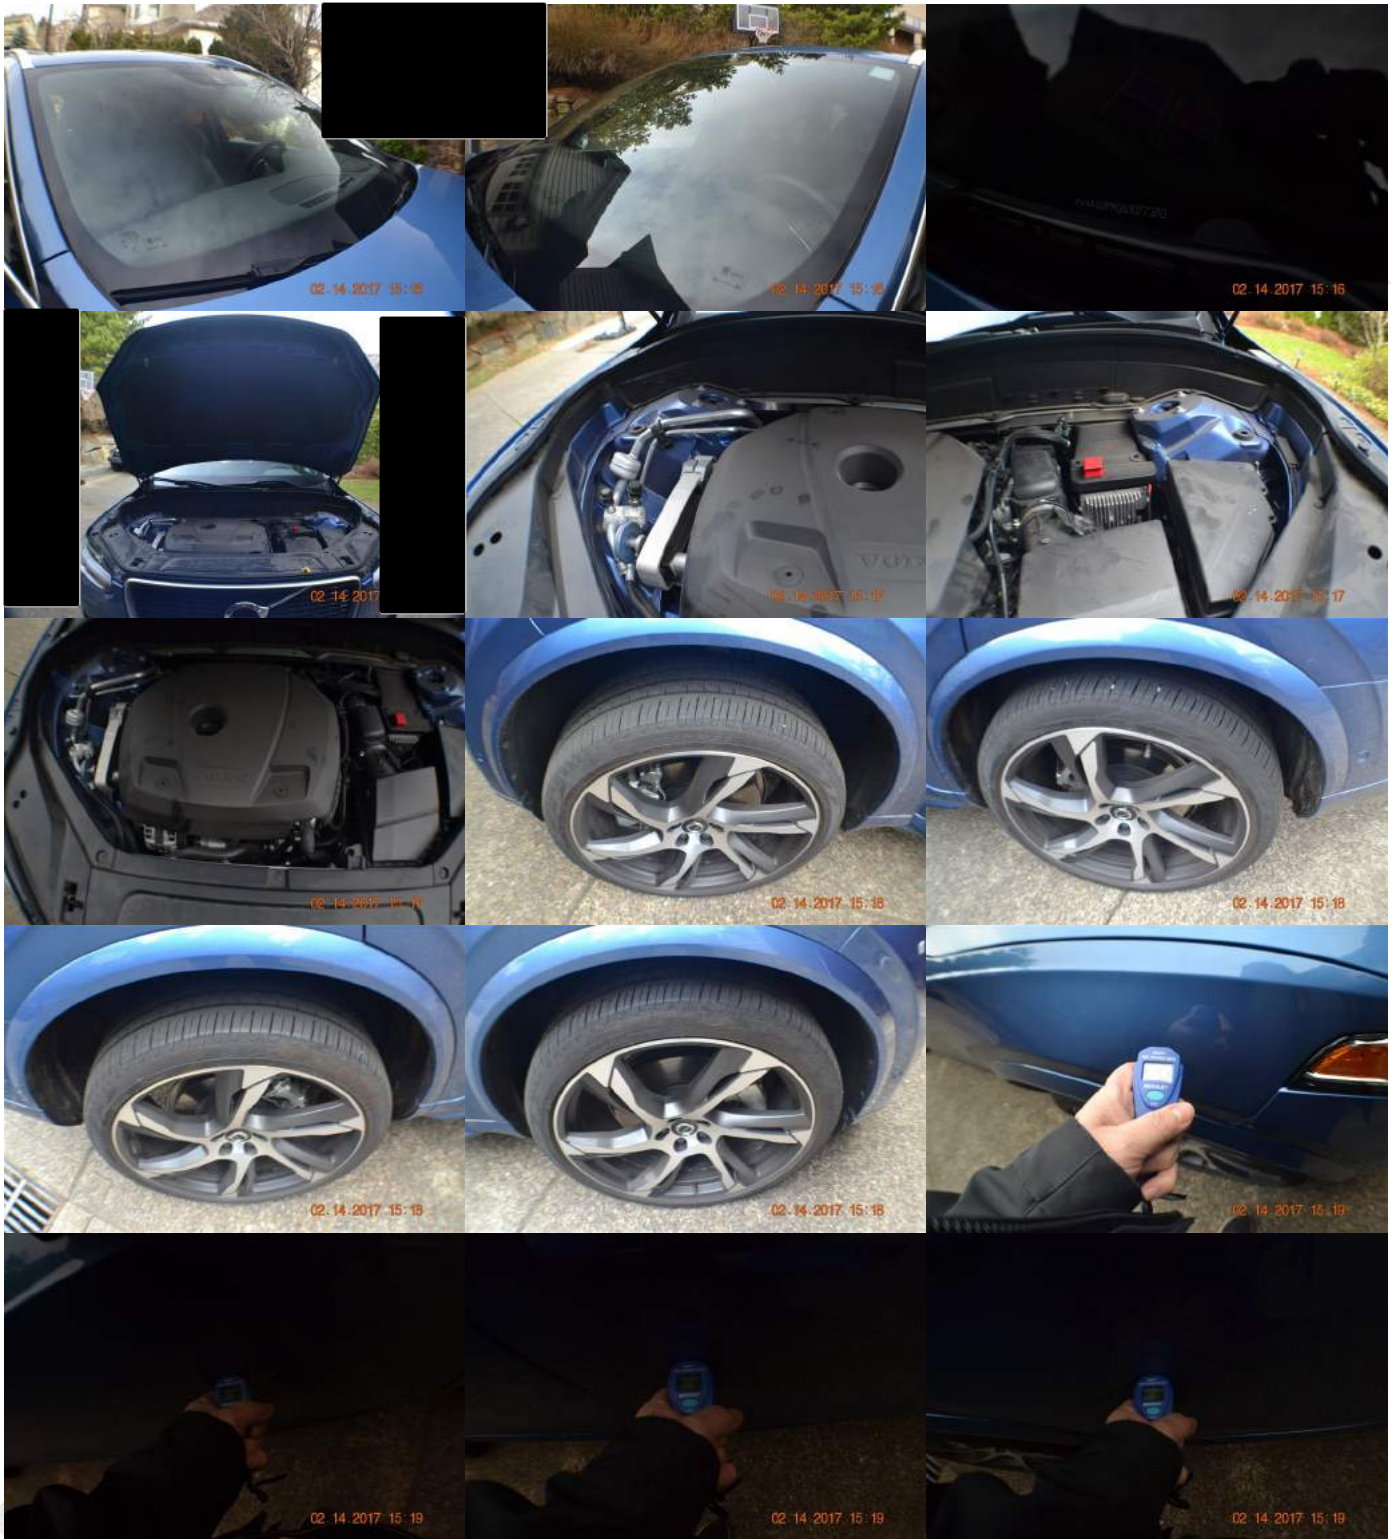
# PHYSICAL INSPECTION IMAGES

The subject vehicle's condition is normal for the year, miles and model. Under close inspection, the vehicle requires some reconditioning, but overall, the vehicle has a nice marketable color, with a high gloss paint finish. The body panels are in excellent condition with no door dings, chips or damage. The Windshield and other glass had no signs of pitting, scratches, chips or damage. The interior is marketable.

During the inspection, I run an 8.5mm x 5 meter borescope into the inner panels to look for any signs of prior damage and/or bad repairs. I found no signs of prior accidents to the vehicle.

including tool marks and broken paint on many of the bolts and nuts related to the repairs. It would be very easy to tell this vehicle had been in a severe accident which required the rear hatch to be removed.
